An Investigation of the Therac-25 Accidents

Nancy G. Leveson, University of Washington

Clark S. Turner, University of California, Irvine

A thorough account of the Therac-25 medical electron accelerator accidents reveals previously unknown details and suggests ways to reduce risk in the future.

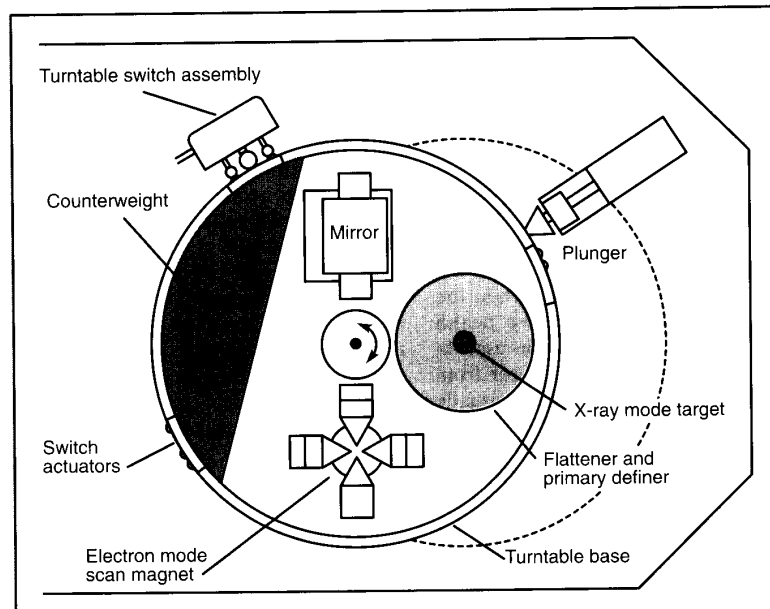
Figure B. Upper turntable assembly.

hazard of dual-mode machines: If the turntable is in the wrong position, the beam flattener will not be in place.

No accelerator beam is expected in the field-light position. A stainless steel mirror is placed in the beam path and a light simulates the beam. This lets the operator see precisely where the beam will strike the patient and make necessary adjustments before treatment starts. There is no ion chamber in place at this turntable position, since no beam is expected.

cate turntable position that tolerated a 1-bit error: The code would still unambiguously reveal correct position with any one microswitch failure.

The modifications recommended in the Symonds report included redesigning the microswitch and changing the way the computer handled malfunction conditions. In particular, treatment was to be terminated in the event of a dose-rate malfunction, giving a treatment "suspend." This would have removed the option to proceed simply by pressing the "P" key. The report also made recommendations regarding collimator test procedures and message and command formats. A November 8, 1985 letter signed by Ernest Létourneau, M.D., director of the CRPB, asked that AECL make changes to the Therac-25 based on the Symonds report "to be in compliance with the RED Act."

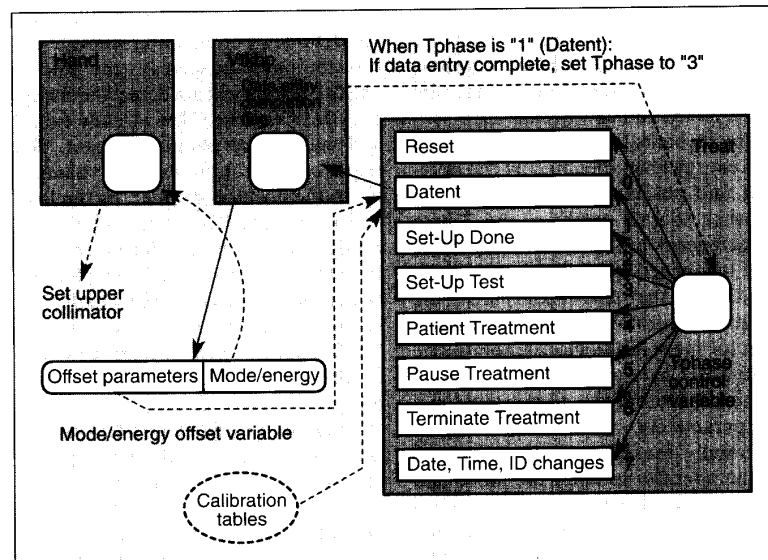
Figure 2. Tasks and subroutines in the code blamed for the Tyler accidents.

shared variable (Data-entry completion flag) to determine whether the prescription data has been entered. The keyboard handler recognizes the completion of data entry and changes the Data-entry completion variable to denote this. Once the Data-entry completion variable is set, the Datent subroutine detects the variable's change in status and changes the value of Tphase from 1 (Data Entry) to 3 (Set-Up Test). In this case, the Datent subroutine exits back to the Treat subroutine, which will reschedule itself and begin execution of the Set-Up Test subroutine. If the Data-entry completion variable has not been set, Datent leaves the value of Tphase unchanged and exits back to Treat's main line. Treat will then reschedule itself, essentially rescheduling the Datent subroutine.

Upon exit from the Magnet subroutine, the data-entry subroutine (Datent) checks the data-entry completion variable. If it indicates that data entry is complete, Datent sets Tphase to 3 and Datent is not entered again. If it is not set, Datent leaves Tphase unchanged, which means it will eventually be re-scheduled. But the data-entry completion variable only indicates that the cursor has been down to the command line, not that it is still there. A potential race condition is set up. To fix this, AECL introduced another shared variable controlled by the keyboard handler task that indicates the cursor is not positioned on the command line. If this variable is set, then prescription entry is still in progress and the value of Tphase is left unchanged.

lems in the data-entry routines that allowed the code to proceed to Set-Up Test before the full prescription had been entered and acted upon. The Yakima accident involves problems encountered later in the logic after the treatment monitor Treat reaches Set-Up Test.

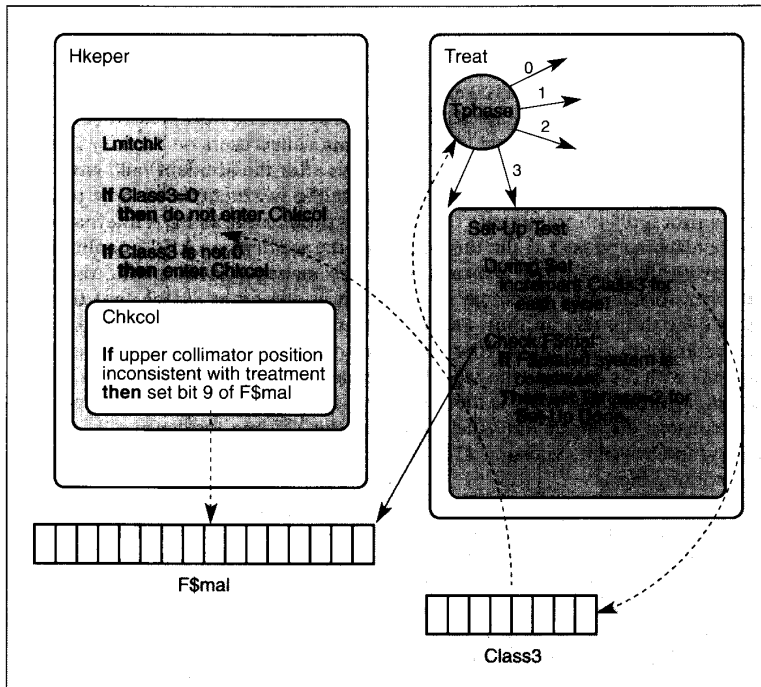
Figure 4. Yakima software flaw.

This situation probably occurred in the Hamilton, Ontario, accident a couple of years ago. It was not discovered at that time and the cause was attributed to intermittent interlock failure. The subsequent recall of the multiple microswitch logic network did not really solve the problem.

The second Yakima accident was again attributed to a type of race condition in the software — this one allowed the device to be activated in an error setting (a "failure" of a software interlock). The Tyler accidents were related to prob-
